# PROPERTY INSPECTION REPORT

***InFocus Home Inspection LLC***

**808 Yourstreet, Lexington KY 40517**

**Date of Inspection: 8/7/2026**

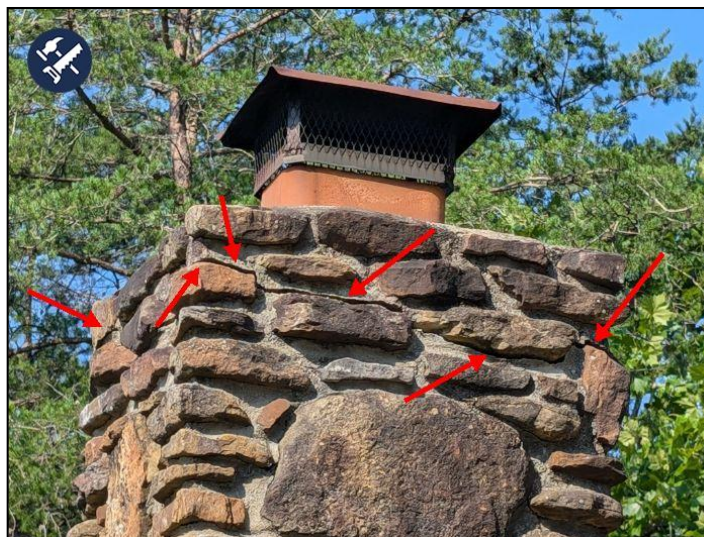
Page 11 Item: 3 Chimney

The chimney cap has cracked this can allow water to penetrate the chimney. During the freeze and thaw cycle this crack will continue to expand. I recommend having a qualified masonry worker assess the chimney cap to see if it should be replaced or repaired. Any cracks should be caulked with a mortar compatible caulking to prevent water penetration.

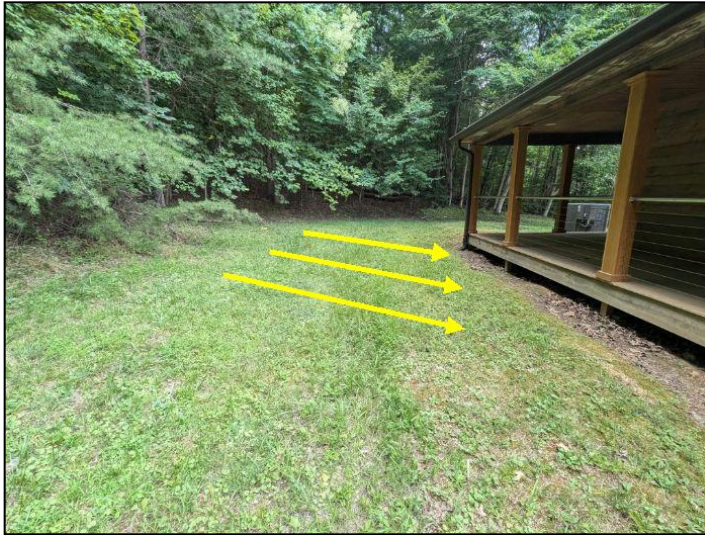
Page 19 Item: 1   Grading

The ground slopes toward the foundation in the northwest corner of the house. Evidence was observed that surface runoff has entered the basement window. I recommend installing a drainage ditch from the northwest corner to the southwest corner of the house.

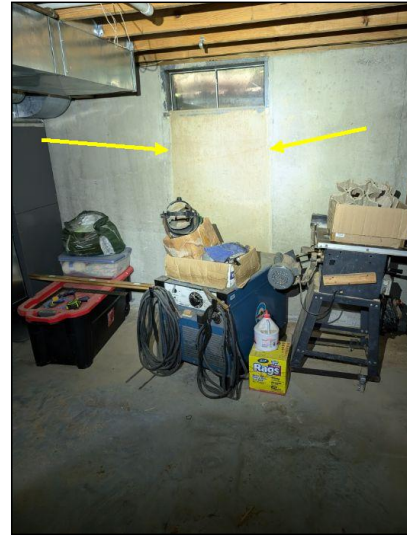
The ground slopes toward the foundation in the northwest corner of the house. Evidence was observed that surface runoff has entered the basement window. I recommend installing a drainage ditch from the northwest corner to the southwest corner of the house.

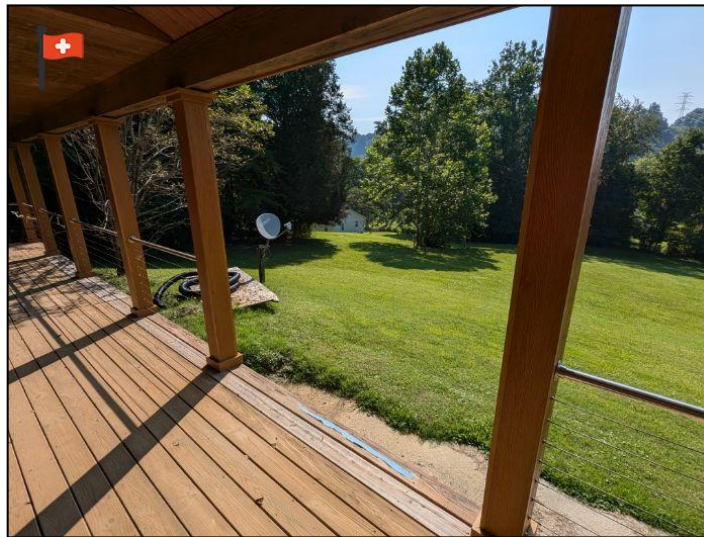
Page 19 Item: 2   Stairs &amp; Handrail

The deck does not have stairs installed for the front entry, this leaves a section of railing open which is a potential safety issue. I recommend installing stairs with a hand railing.

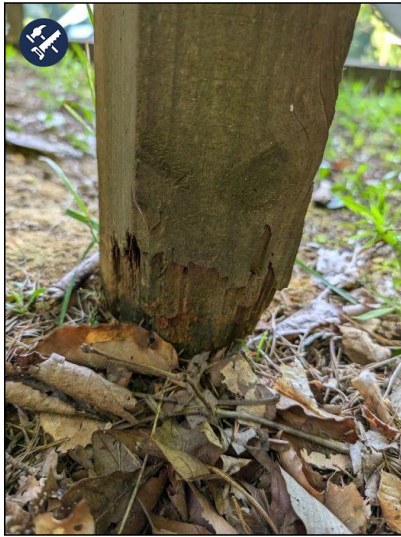
Page 20 Item: 5 Deck

Deck posts are in contact with soil. Several posts show signs of water damage/rot. I recommend pouring footings/piers with anchor plates and replacing damaged posts.

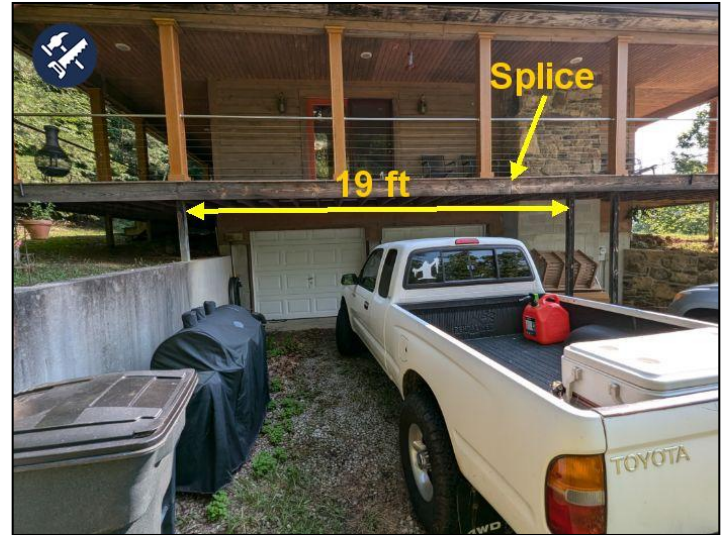
The lumber spanning over the garage door opening is undersized for the span. The band board (rim joist) is a 2x8 and a 2x10. This board is showing signs of sagging and has a splice before the post. I recommend repair. Consider using 6x6 posts and several 2X10s attached together to create a beam.

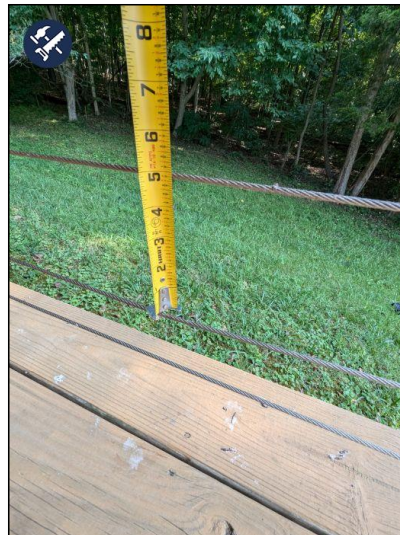
Cable railing is installed, this railing is not considered safe for children because it is climbable and has openings larger than 4 inches. I recommend considering a railing system that is safe for children.

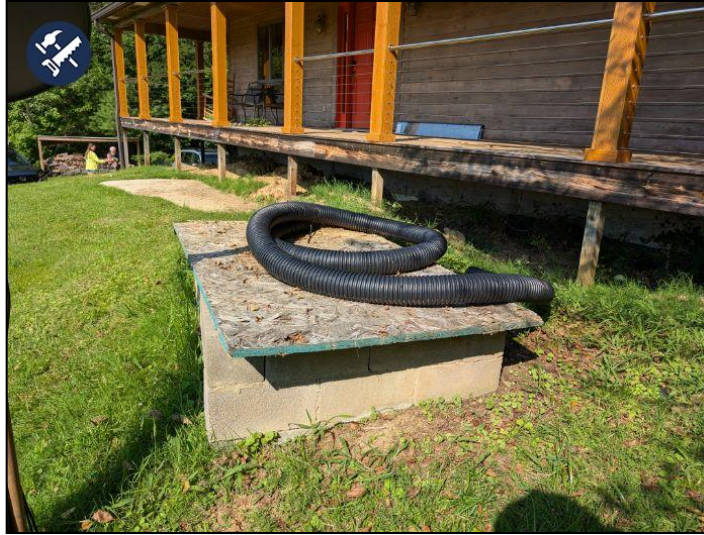
| Page 23 Item: 6 | Cistern |

The cistern does not have an approved (child safe) covering installed. This is a potential safety hazard. I recommend repair.

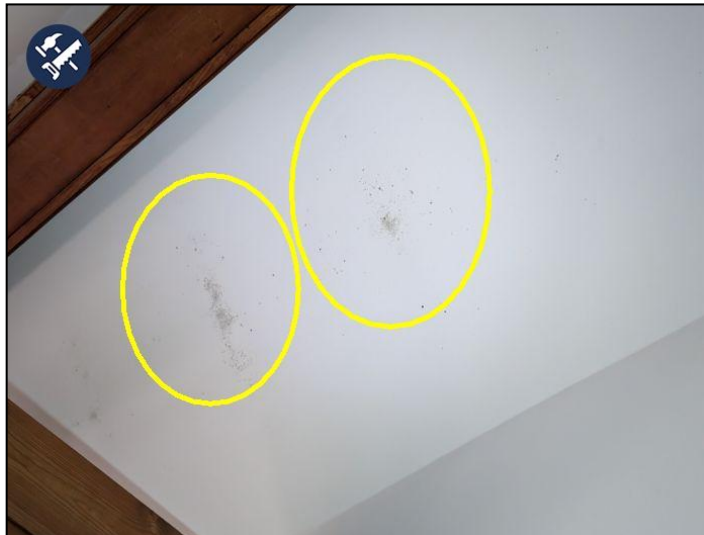
| Page 28 Item: 3 | Ceiling Condition |

Organic- mold-like growth was observed on the ceiling upstairs. This growth seems to be most noticeable on the west side/rear of the house. The cause is unknown. It is possible this could be caused by elevated humidity levels. I recommend cleaning the affected area with a bleach solution. Use a mold killing primer and paint. Monitor the humidity levels with a hygrometer, prevent the humidity from exceeding 60 percent.

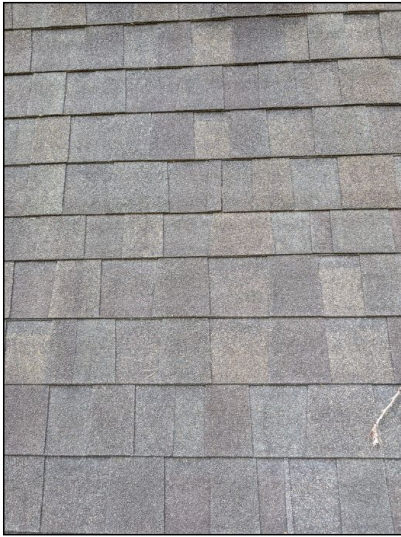
The shingle is an architectural composite shingle, likely 25 to 30 year rating. Based on appearance I estimate the roof to be 8 to 10 years old.

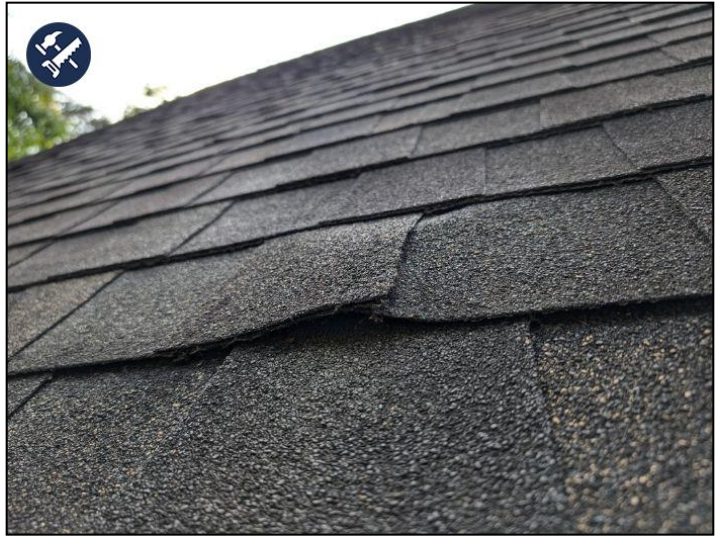
This shingle on the northwest side of the roof is popped up. Likely this is caused by a nail pop or warped sheathing. I recommend repair. Location 10 ft from the hip on the the NW corner.

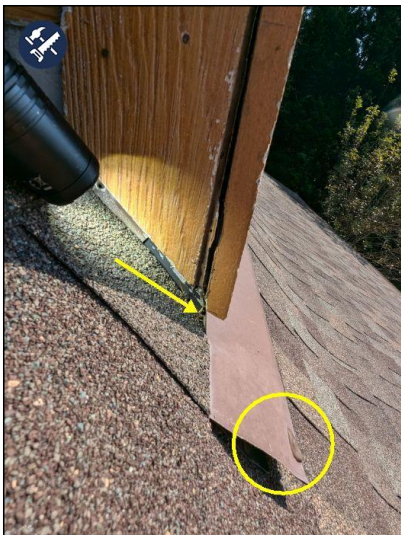
Flashing on middle dormer extends past the corner, this can create a lip that directs water behind flashing. Also the nails on the bottom flashing have popped up.

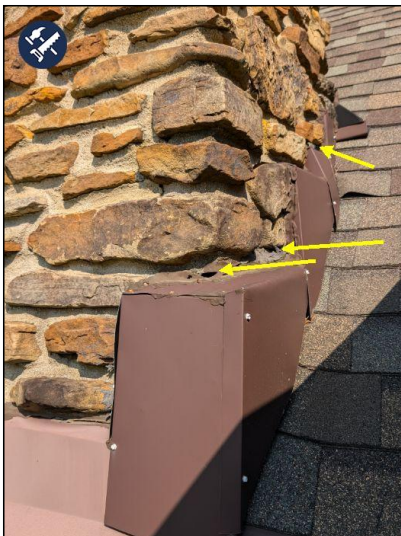
Gaps observed in counter flashing. I recommend sealing any gaps with a mortar compatible caulking.

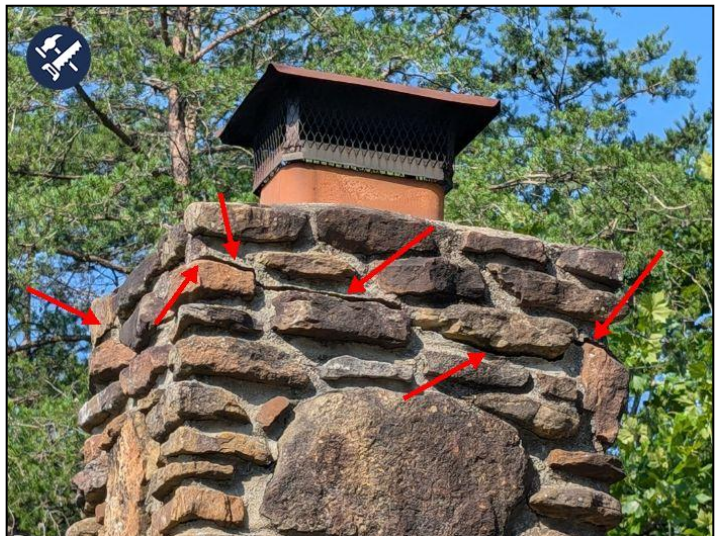
The chimney cap has cracked this can allow water to penetrate the chimney. During the freeze and thaw cycle this crack will continue to expand. I recommend having a qualified masonry worker assess the chimney cap to see if it should be replaced or repaired. Any cracks should be caulked with a mortar compatible caulking to prevent water penetration.

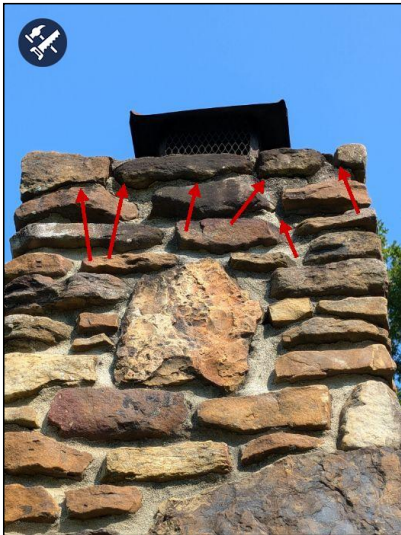
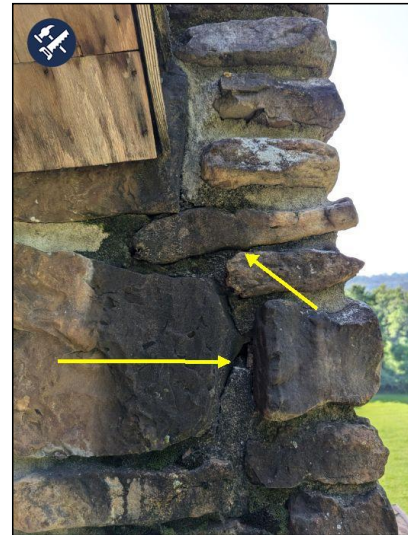
The chimney cap has cracked this can allow water to penetrate the chimney. During the freeze and thaw cycle this crack will continue to expand. I recommend having a qualified masonry worker assess the chimney cap to see if it should be replaced or repaired. Any cracks should be caulked with a mortar compatible caulking to prevent water penetration.

On the side of the chimney facing the driveway there are some gaps visible in the mortar. I recommend repairing these gaps by tuck pointing with mortar or using a mortar compatible caulking.

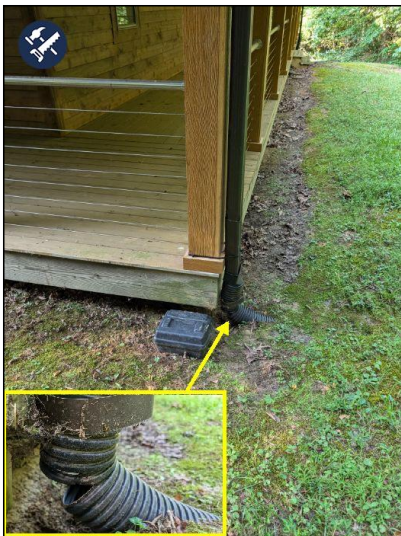
The gutter drainage piping is broken on the northwestern corner of the house. This is funneling water under the porch, I recommend repairing/replacing the drain piping and making sure the outlet is directed away from the foundation.

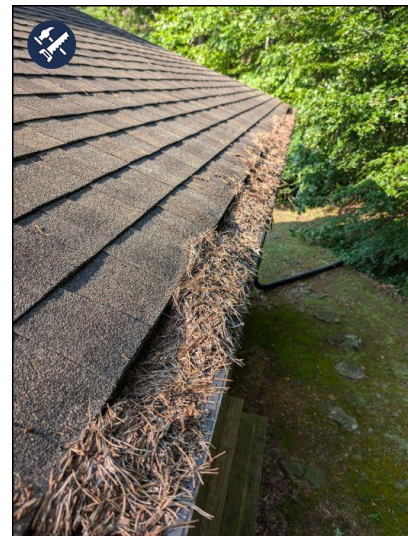
The gutter guards were covered with debris on the west and parts of the north and south sides of the house. I recommend removing the debris.

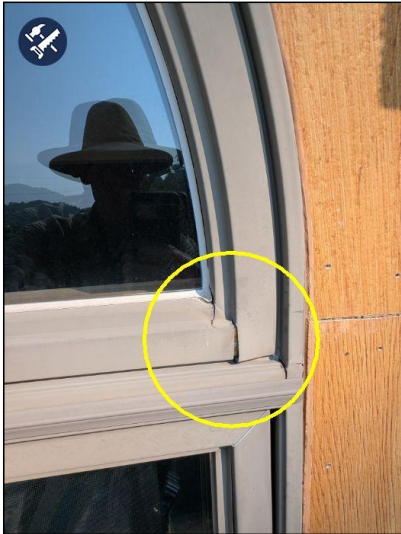
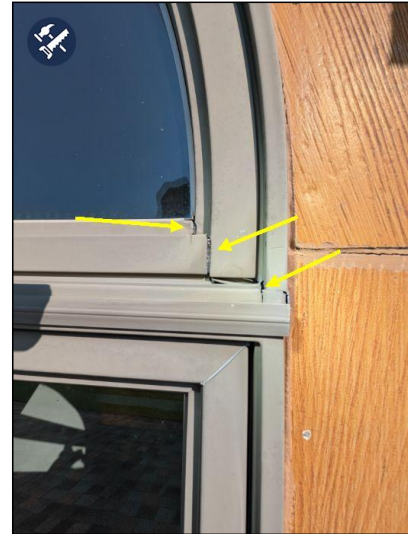
The windows installed on the dormers are vinyl coated wood. The vinyl has cracked in some places from sun damage. I recommend caulking any gaps. When facing the house the windows on the left and right have damage like this photo.

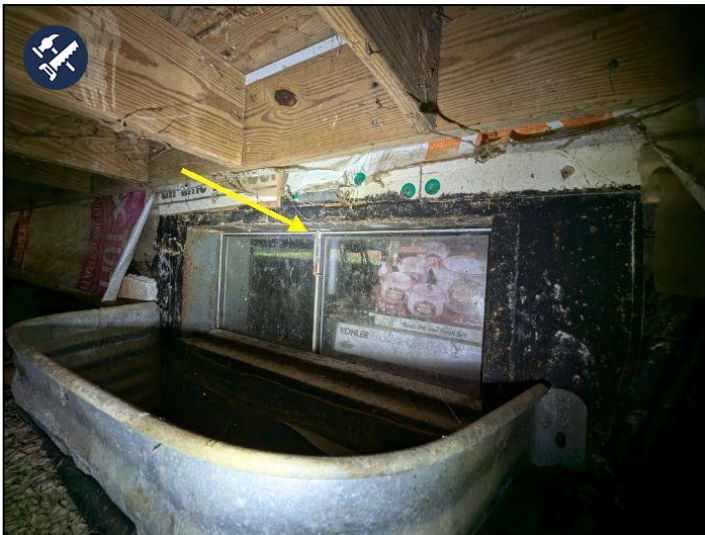
Fun Fact: The first basement window on the west side is installed backwards. (the lock is on the outside) I recommend repair.

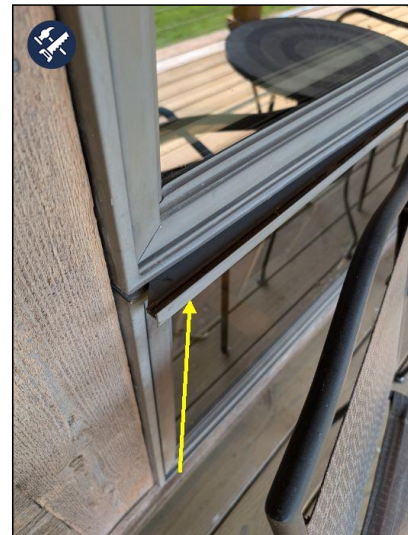
This piece of trim was loose on the window next to the front entry. I recommend repair.

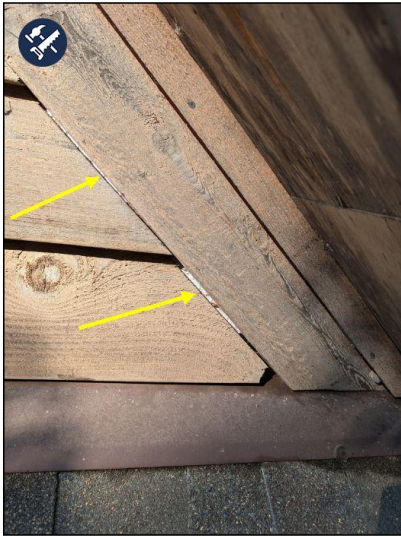
Some gaps were observed in the siding. I recommend caulking any gaps to prevent water intrusion.

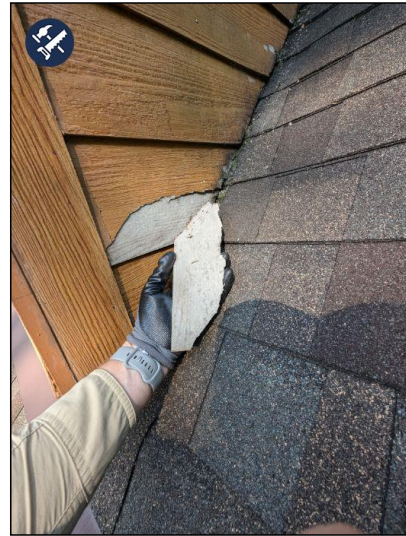
Siding is in contact with the roof, when moisture wicks up during the wintertime the freeze and thaw cycle can cause de-lamination. I recommend replacing any damaged siding and avoiding having the siding contact the roof.

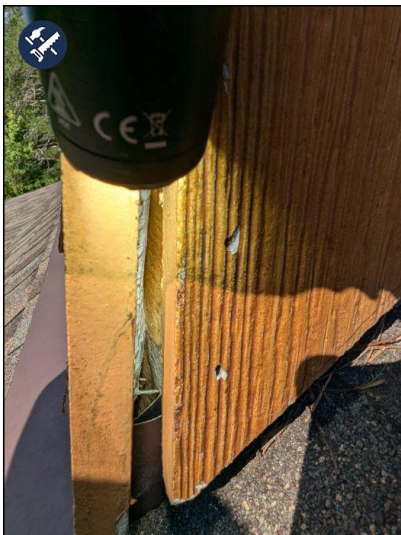
The corner trim/siding on the middle dormer has separated. I recommend reattaching this trim piece and caulking any cracks/seams.

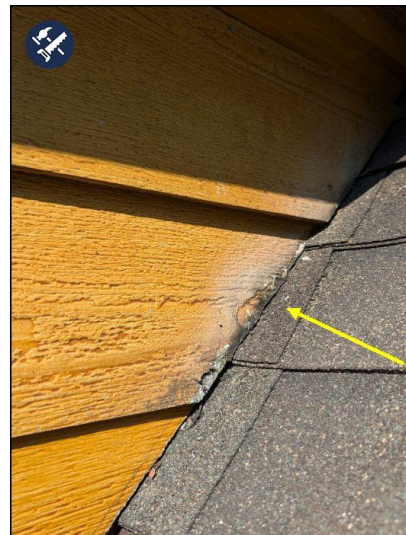
Another picture of de-laminating siding cause by contact with the roof.

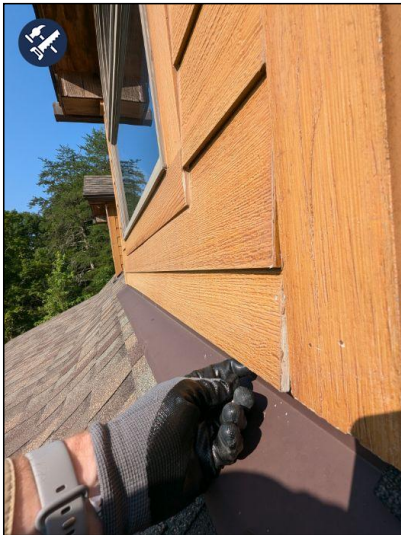
Some siding on dormer was loose. I recommend reattaching and caulking joints.

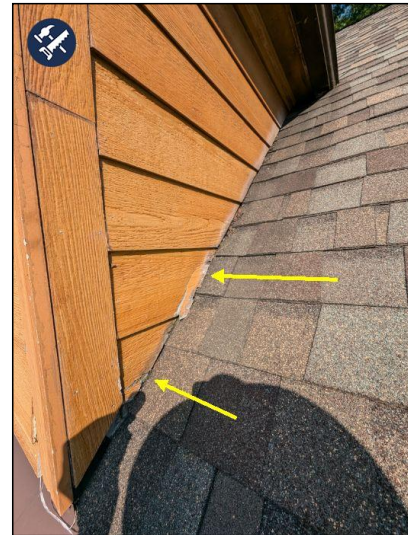
Siding is in contact with the roof, when moisture wicks up during the wintertime the freeze and thaw cycle can cause de-lamination. I recommend replacing any damaged siding and avoiding having the siding contact the roof.

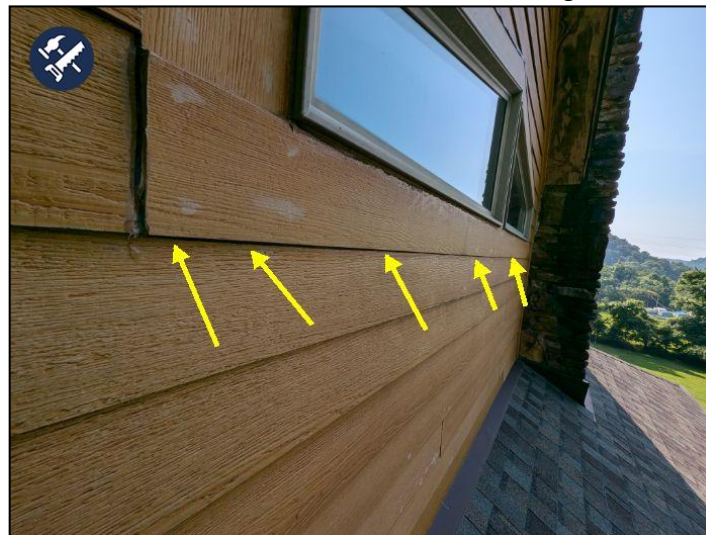
This seam is not lapped, it's important to keep this sealed. I recommend caulking.

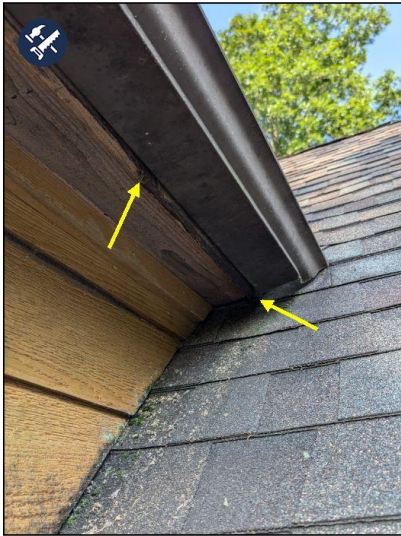
Wood fascia is in contact with the roof, this allows water from rain to wick into the wood. In general it is recommended that all siding/fascia/soffit be at least 1 inch off the roof surface.

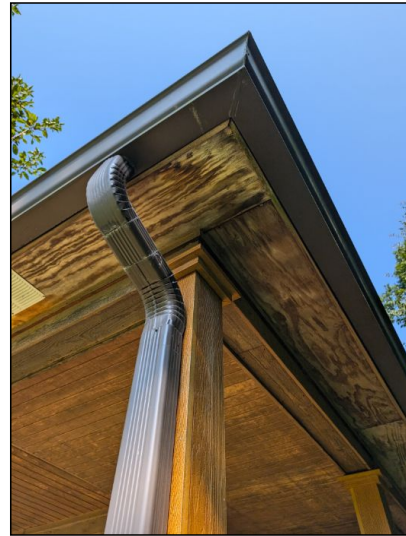
Water stains were observed on the soffit, The source is unknown, this could be from a time when gutters were not installed or when they were clogged.

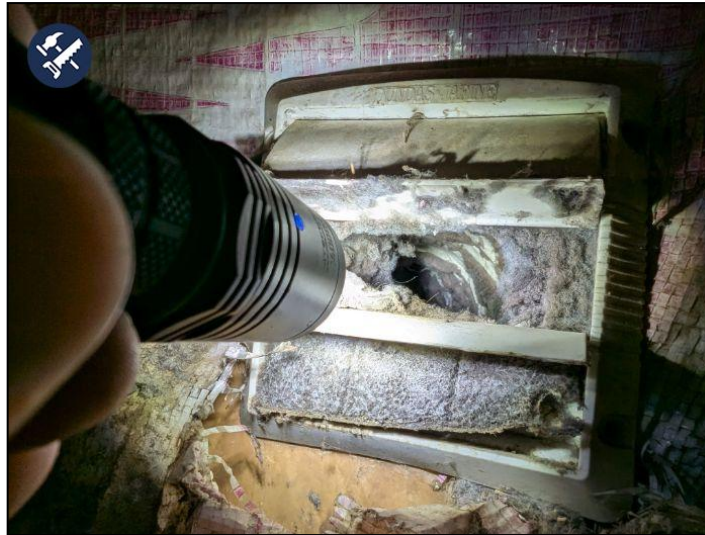
The dryer vent is clogged. I recommend cleaning the dryer vent piping periodically to prevent this. Additionally, the dryer vent is located far from the dryer, replacing the dryer vent piping with a solid piping could reduce maintenance.

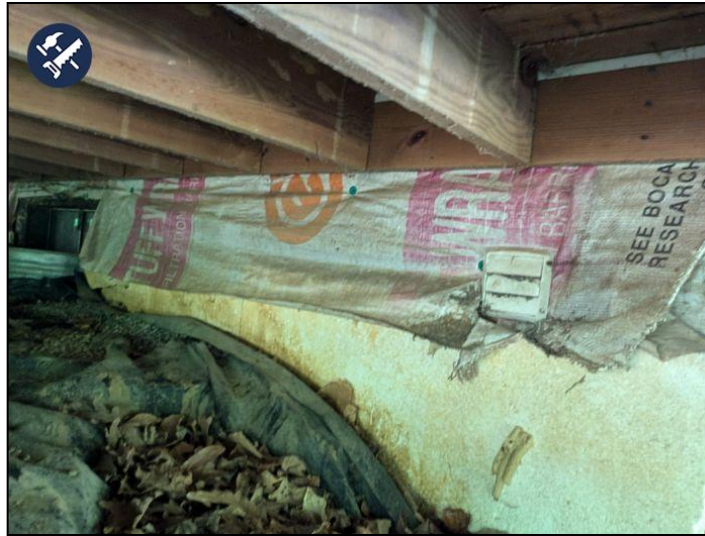
The foundation cladding is incomplete. House wrap is not UV resistant and should be covered with siding. I recommend repair.

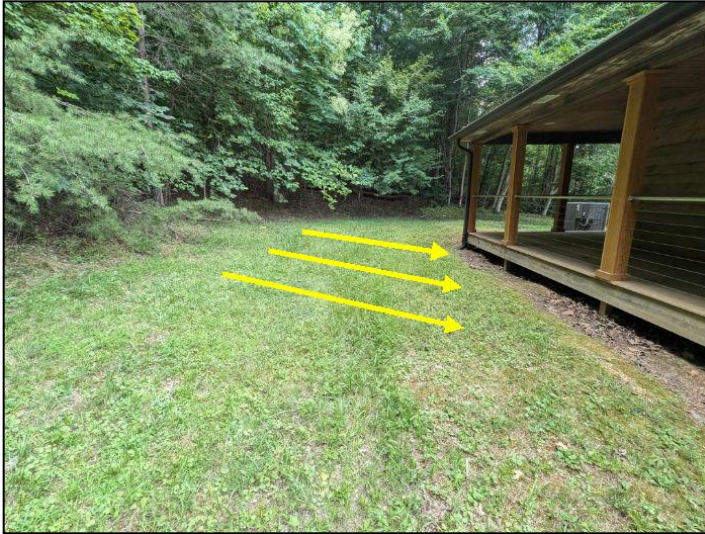
The ground slopes toward the foundation in the northwest corner of the house. Evidence was observed that surface runoff has entered the basement window. I recommend installing a drainage ditch from the northwest corner to the southwest corner of the house.

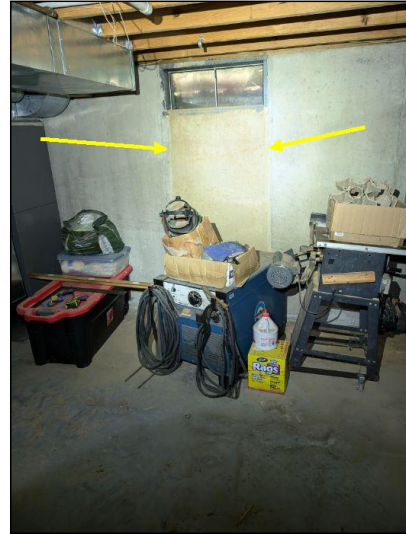
The ground slopes toward the foundation in the northwest corner of the house. Evidence was observed that surface runoff has entered the basement window. I recommend installing a drainage ditch from the northwest corner to the southwest corner of the house.

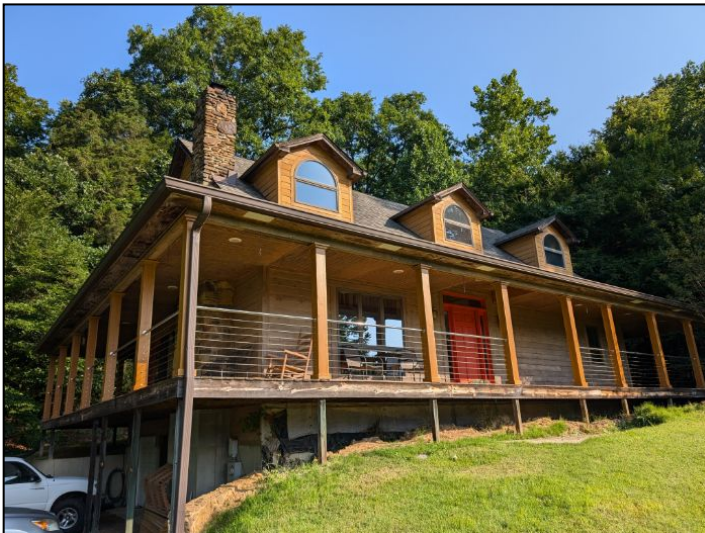
Cable railing is installed, this railing is not considered safe for children because it is climbable and has openings larger than 4 inches. I recommend considering a railing system that is safe for children.

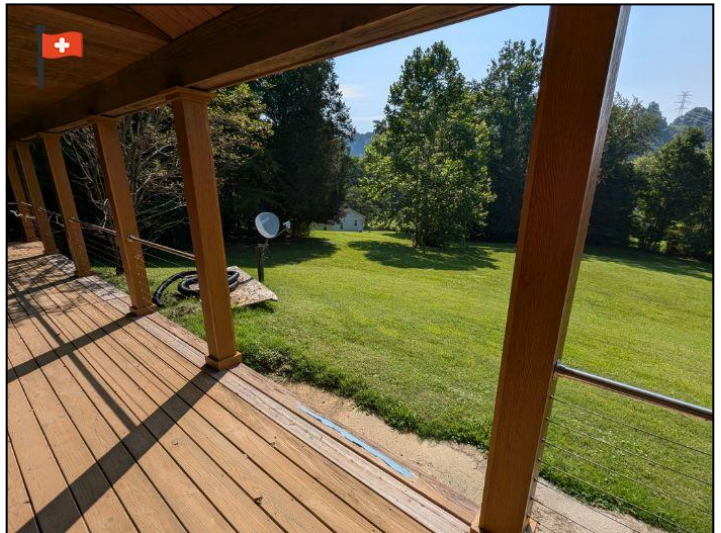
The deck does not have stairs installed for the front entry, this leaves a section of railing open which is a potential safety issue. I recommend installing stairs with a hand railing.

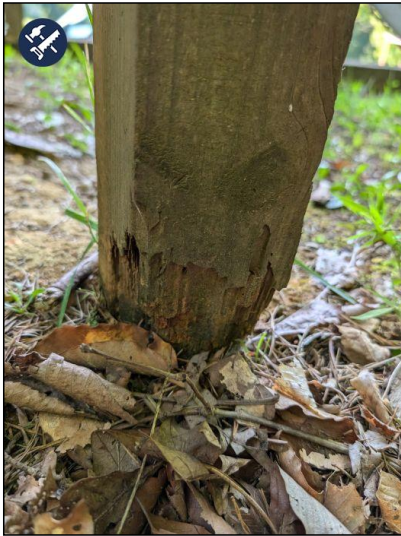
Deck posts are in contact with soil. Several posts show signs of water damage/rot. I recommend pouring footings/piers with anchor plates and replacing damaged posts.

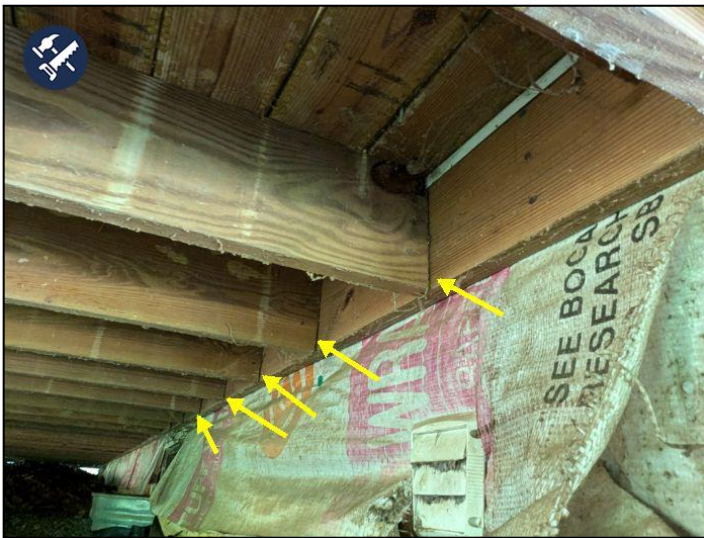
No joist hangers were observed. Joist hangers are recommended.

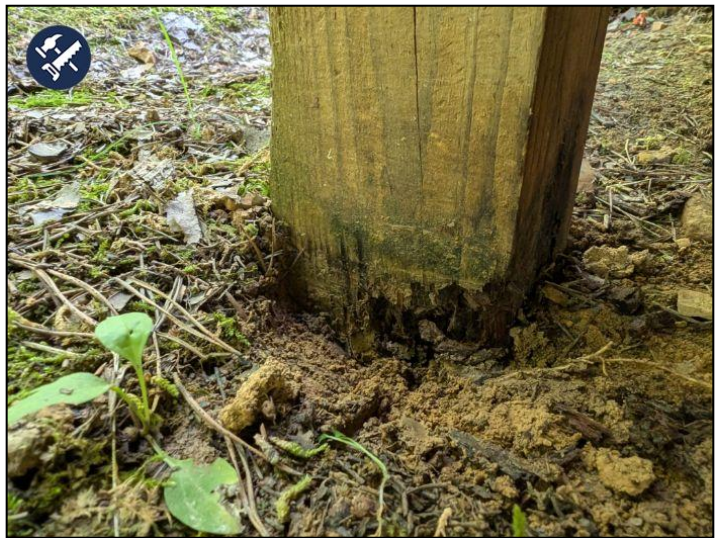
Posts are in contact with the ground. This has caused damage to the posts, I recommend repair.

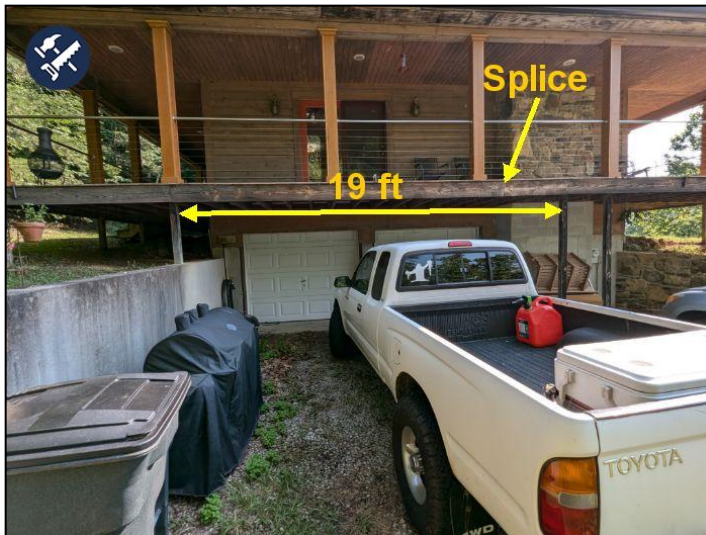
The lumber spanning over the garage door opening is undersized for the span. The band board (rim joist) is a 2x8 and a 2x10. This board is showing signs of sagging and has a splice before the post. I recommend repair. Consider using 6x6 posts and several 2X10s attached together to create a beam.

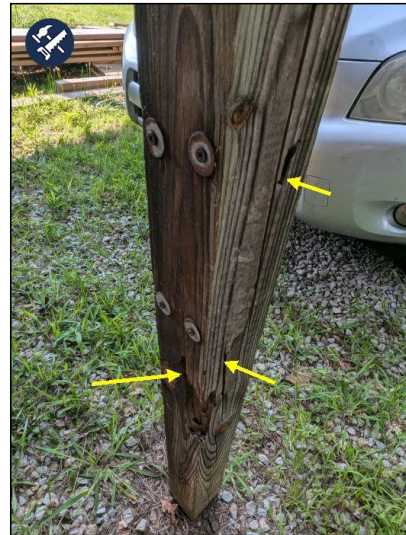
This post has been broken and spliced. I recommend repair.

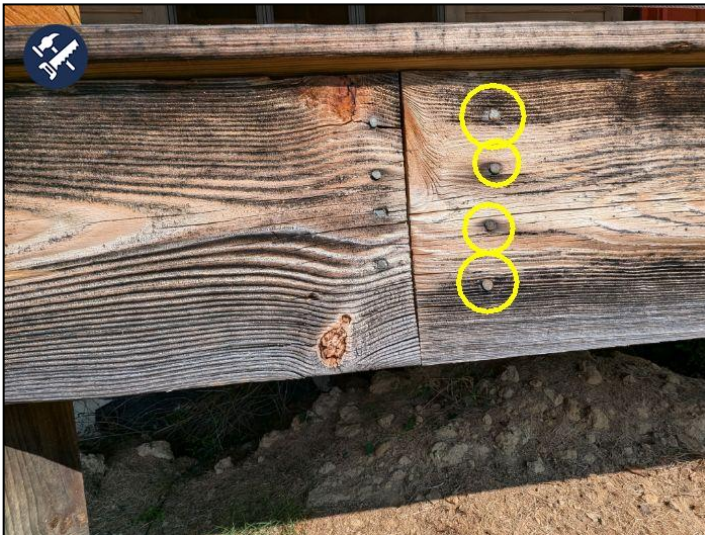
This splice was not on a post. Structural fasteners such as lag bolts/screws were not observed. I recommend installing structural fasteners.

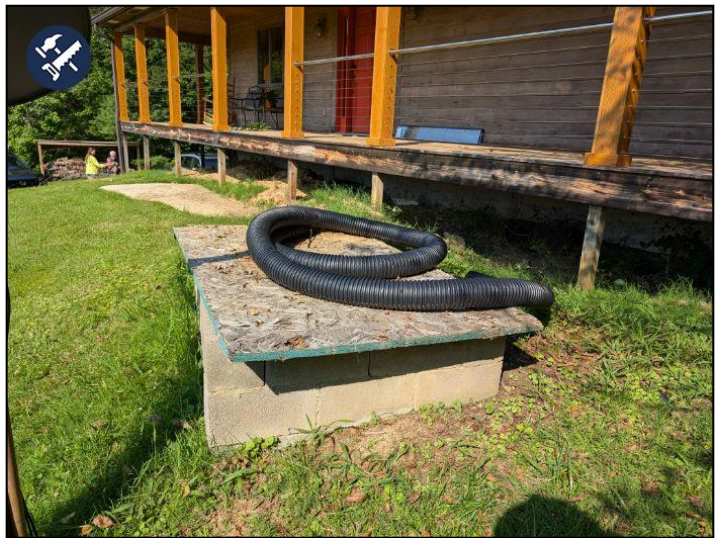
The cistern does not have an approved (child safe) covering installed. This is a potential safety hazard. I recommend repair.

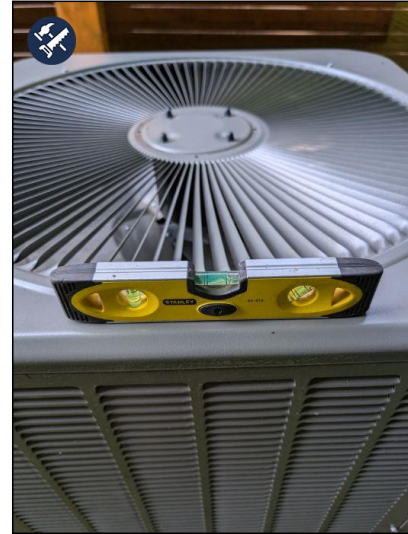
This heat pump unit was not level. I recommend leveling the unit.

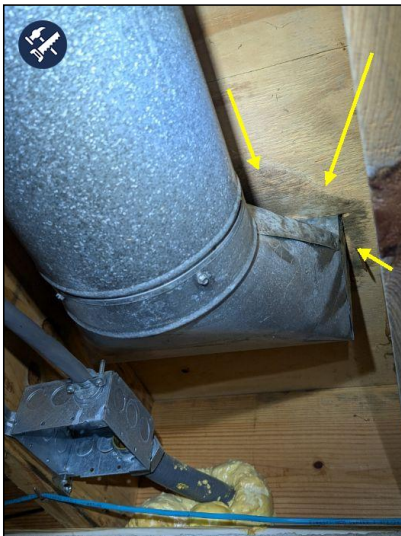
Organic-mold-like growth observed around supply vent in basement, this is the supply vent to the room on the north west corner of the house. I recommend cleaning the affected area.

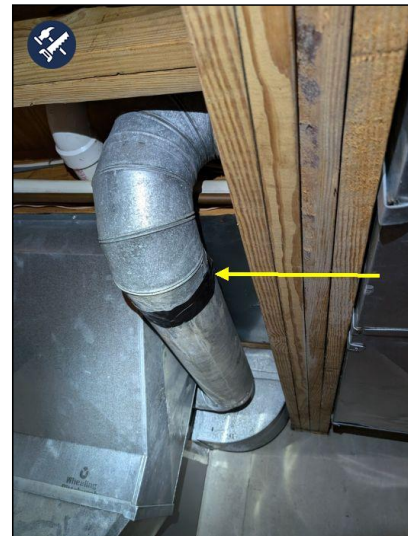
This duct supplies conditioned air to the northwest corner bedroom, this room has a very high volume of air compared with the other rooms. I recommend installing a damper to control the air flow.

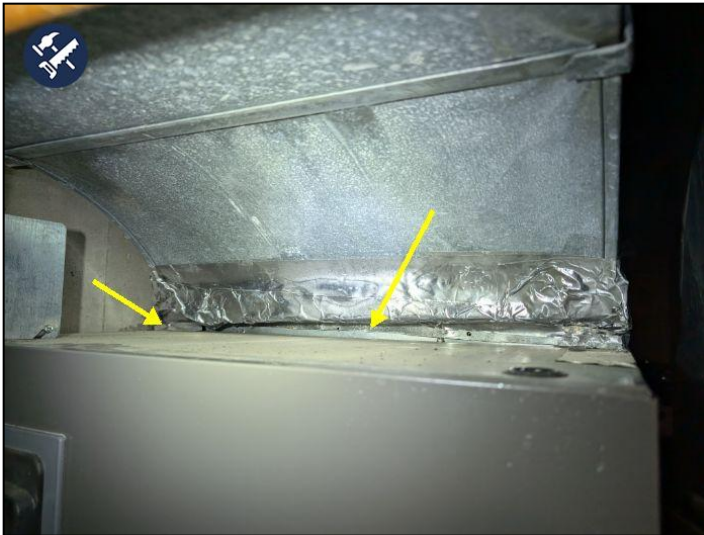
Duct tape/sealant is missing from this area. I recommend repair.

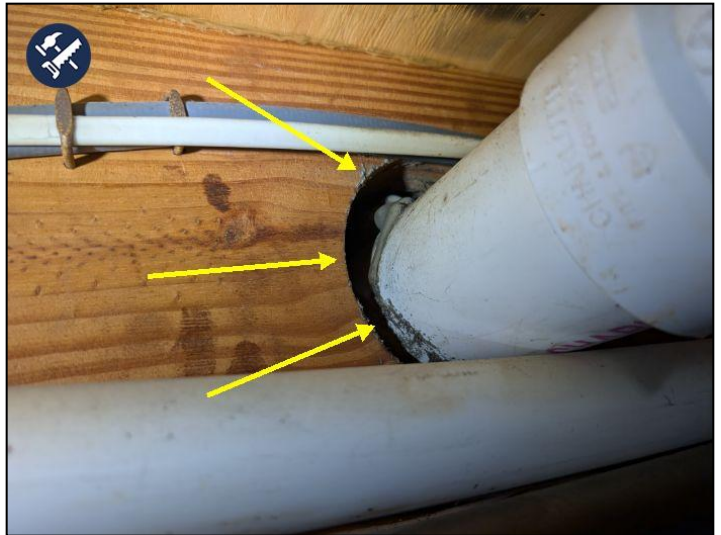
This penetration in the return duct chase is pulling air into the chase from the basement. I recommend sealing this penetration.

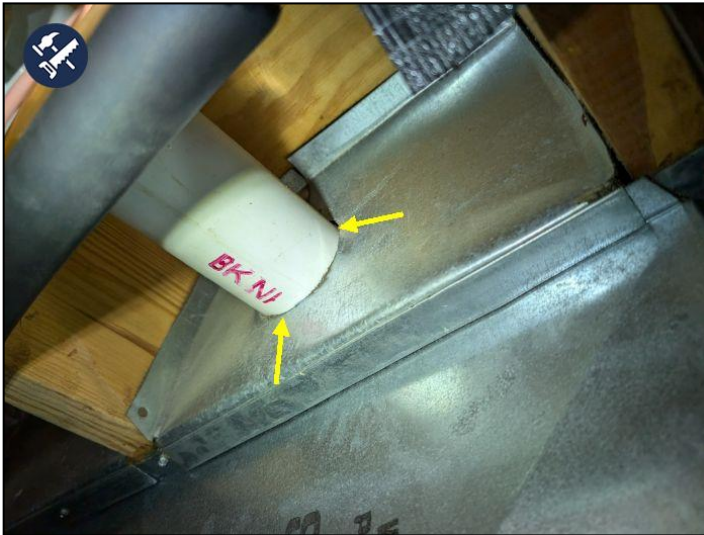
This penetration in the return duct chase is pulling air into the chase from the basement. I recommend sealing this penetration.

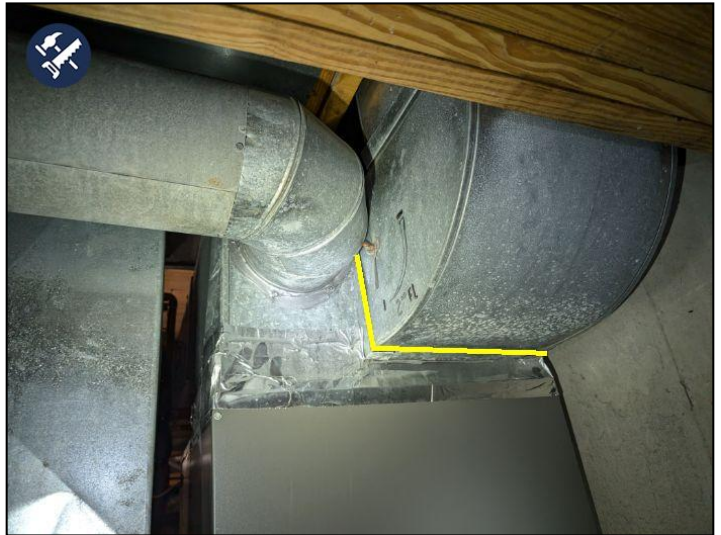
Duct tape/sealant is missing from this area. I recommend repair.

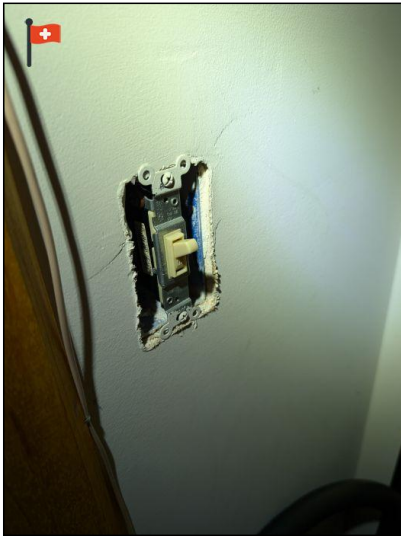
The switch inside the closet near the entry door is missing the cover plate. I recommend installing the cover plate for safety.

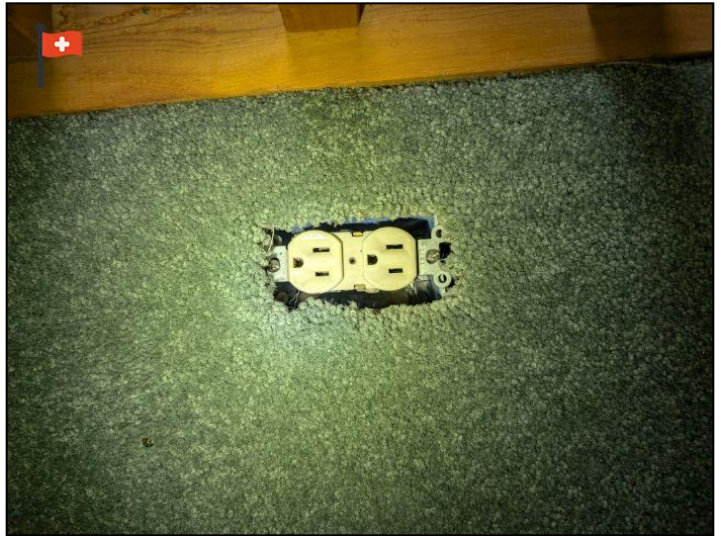
Two outlets are missing the cover plates upstairs. I recommend cover plates for safety.

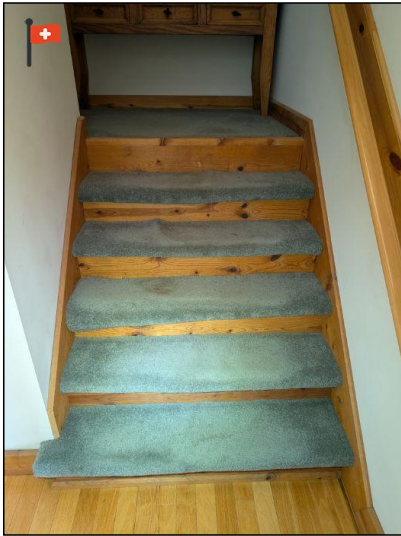
The carpet on the stairs is loose. This could cause tripping. I recommend repair.

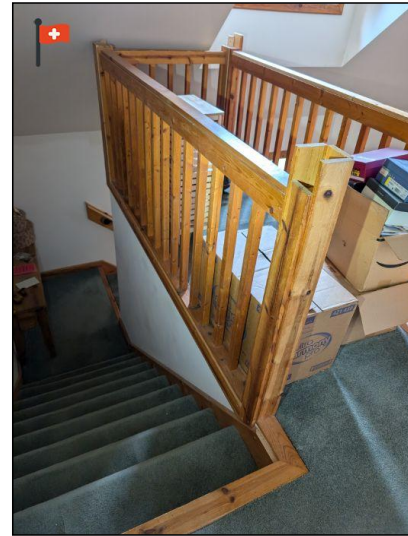
The railing is loose. It is recommended that hand railing can withstand 200 lbs. of horizontal force for safety.

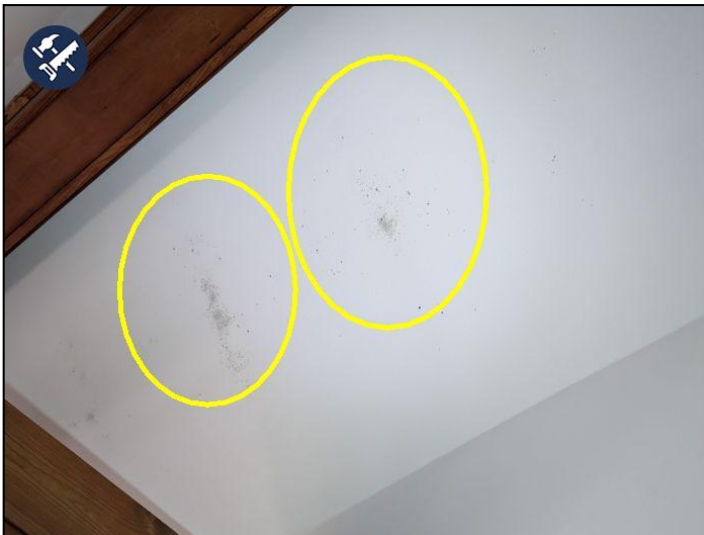
Organic- mold-like growth was observed on the ceiling upstairs. This growth seems to be most noticeable on the west side/rear of the house. The cause is unknown. It is possible this could be caused by elevated humidity levels. I recommend cleaning the affected area with a bleach solution. Use a mold killing primer and paint. Monitor the humidity levels with a hygrometer, prevent the humidity from exceeding 60 percent.

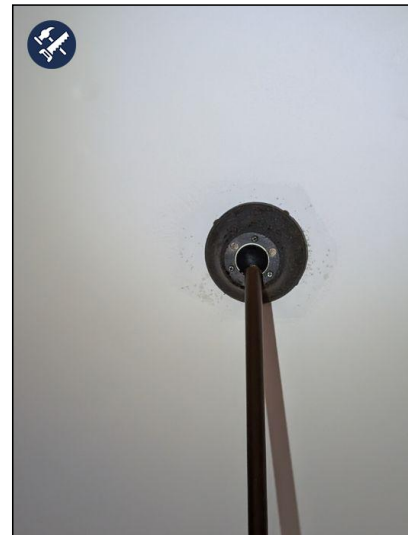
Organic- mold-like growth was observed on the ceiling upstairs. This growth seems to be most noticeable on the west side/rear of the house. Some growth was seen around the ceiling fan base on the east side. The cause is unknown. It is possible this could be caused by elevated humidity levels. I recommend cleaning the affected area with a bleach solution. Use a mold killing primer and paint. Monitor the humidity levels with a hygrometer, prevent the humidity from exceeding 60 percent.

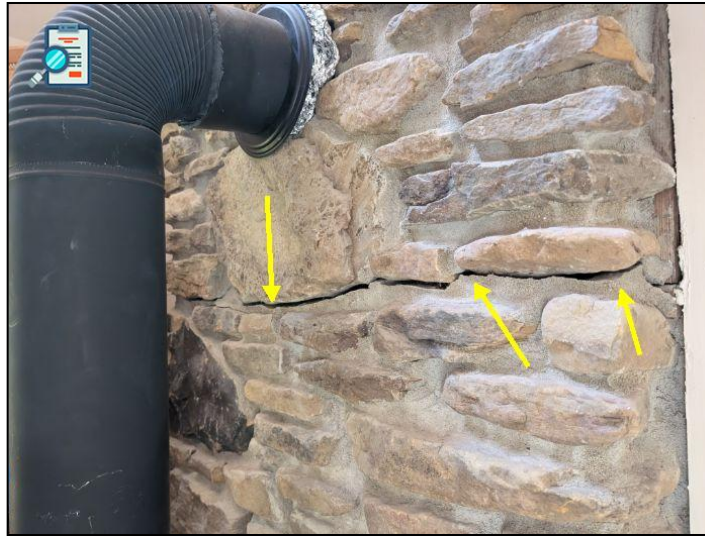
A settling crack was observed on the hearth wall. I recommend repair and monitoring to see if the crack reappears.

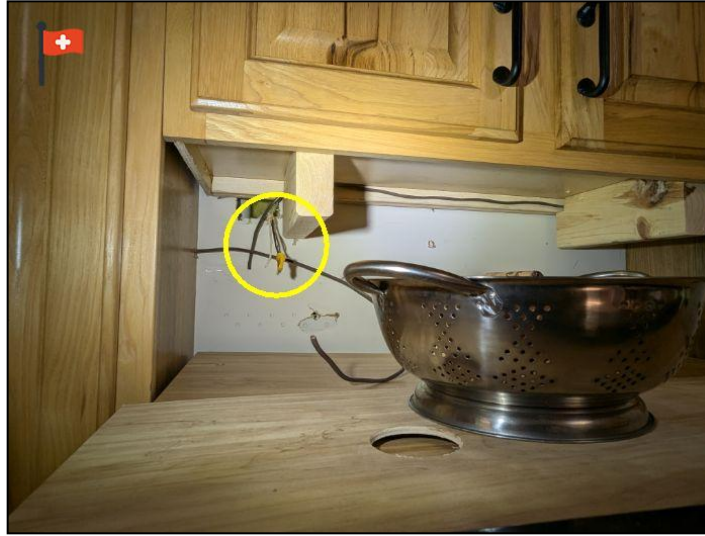
A wire connection is exposed. I recommend wire connections be housed in an electrical box for safety.

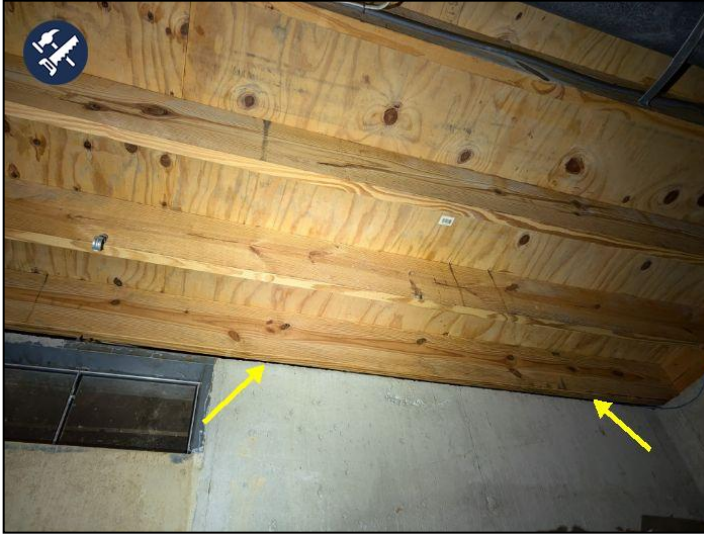
The subfloor is not insulated. Since this house has a full basement it is up to preference if it is insulated. It is recommended that the exterior rim joist and any exterior framed walls be insulated.

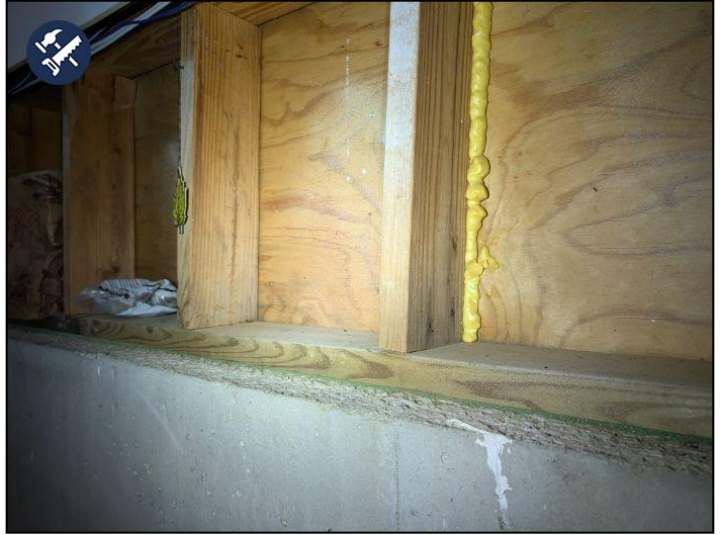
The subfloor is not insulated. Since this house has a full basement it is up to preference if it is insulated. It is recommended that the exterior rim joist and any exterior framed walls be insulated.

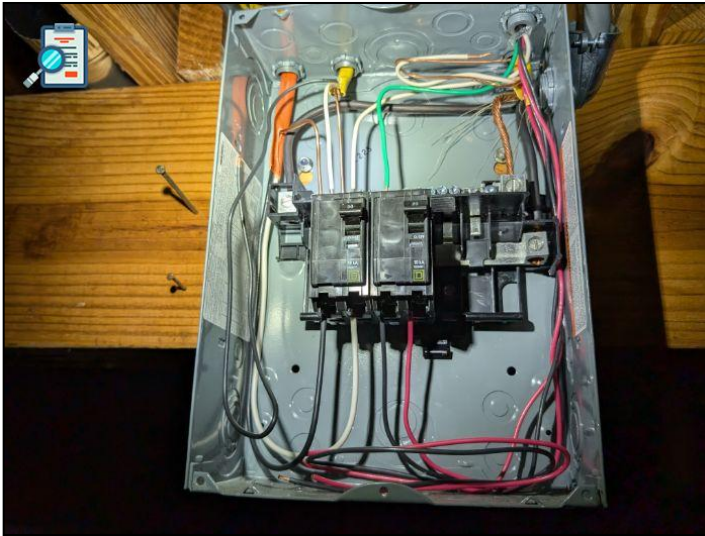
The cover of this sub panel located in the basement was not installed. I recommend installing the sub panel for safety.

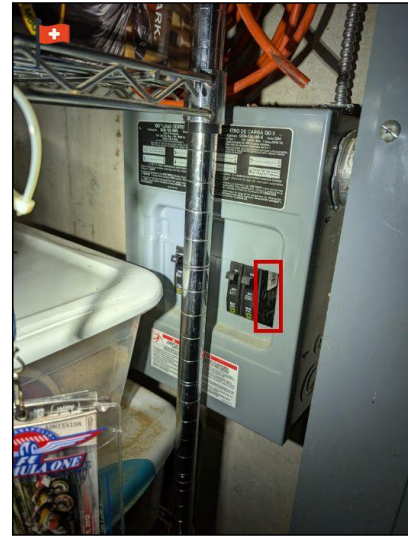
This sub panel next to the electrical panel has an open breaker slot. I recommend installing a breaker filler plate to prevent contact with energized parts for safety.

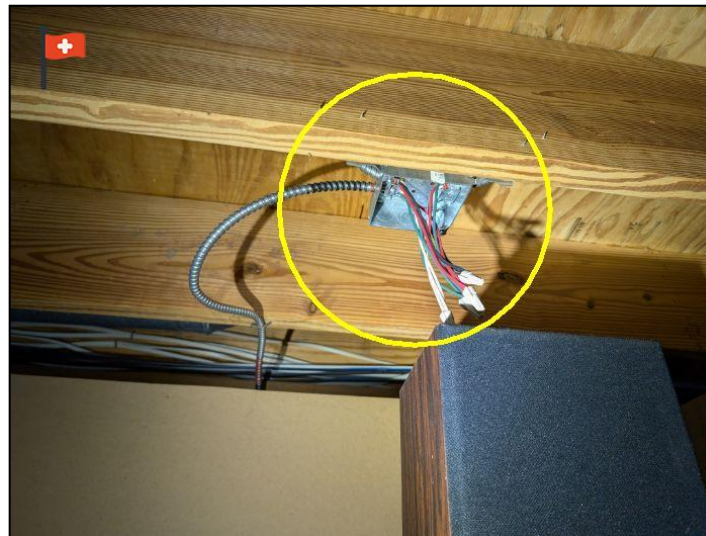
These electrical connections are exposed. It is recommended that connections be concealed in a box with a cover plate.

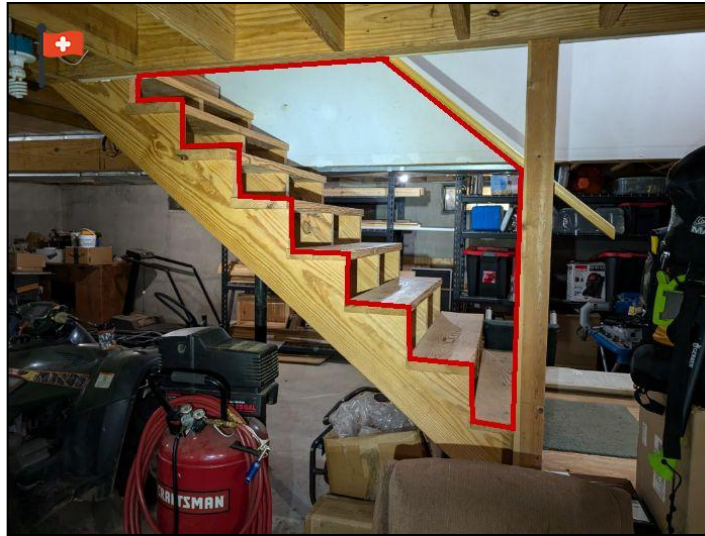
No railing is installed along basement stairs. I recommend installing railing for safety.
