# PROPERTY INSPECTION REPORT

***InFocus Home Inspection LLC***

**808 Yourstreet, Lexington KY 40517**

**Date of Inspection: 8/7/2026**

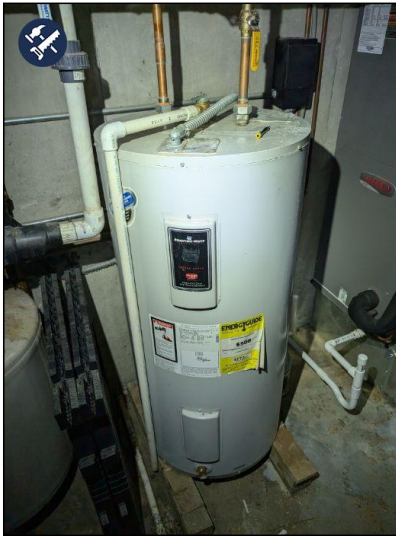
| Page 32 Item: 1 | Water Heater<br>Condition |

The water heater is electric. Brand: Bradford White. Age: Sept. 2009. (15 years old) The average lifespan of an electric hot water heater is 10 years, I recommend budgeting for a replacement.

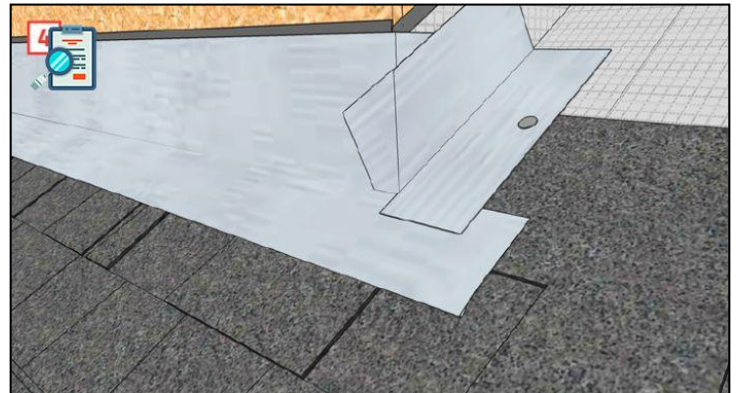
Flashing on middle dormer extends past the corner, this can create a lip that directs water behind flashing. Also the nails on the bottom flashing have popped up.

This image is included for reference: The bottom or "base flashing should be cut flush with the corner of the dormer, the step flashing should lap over this flashing as seen in the picture.

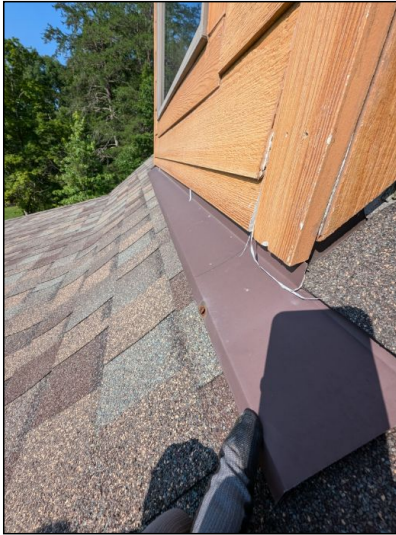
Flashing on the left dormer (when facing the house) extends past the corner, this can create a lip that directs water behind flashing. Also the nails on the bottom flashing have popped up.

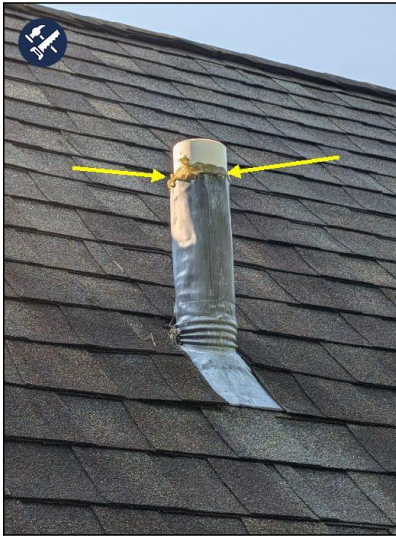
## 5. Plumbing Boot

The plumbing pipe is improperly flashed. This lead boot should fold over into the the pipe. The pipe will need to be cut shorter, another option is to install a different plumbing boot.

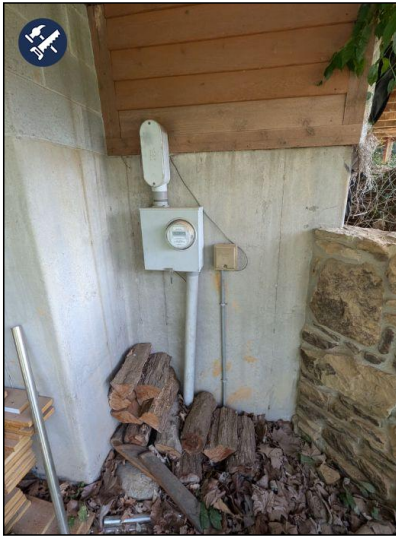
The service entry is underground electric.

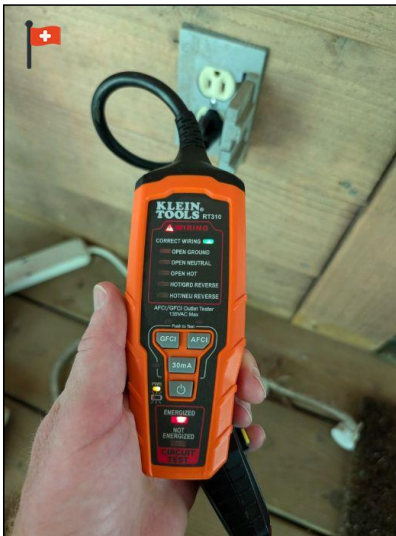
The exterior outlets located around the porch are correctly wired, but are not **GFCI** protected. I recommend GFCI outlets in these locations.

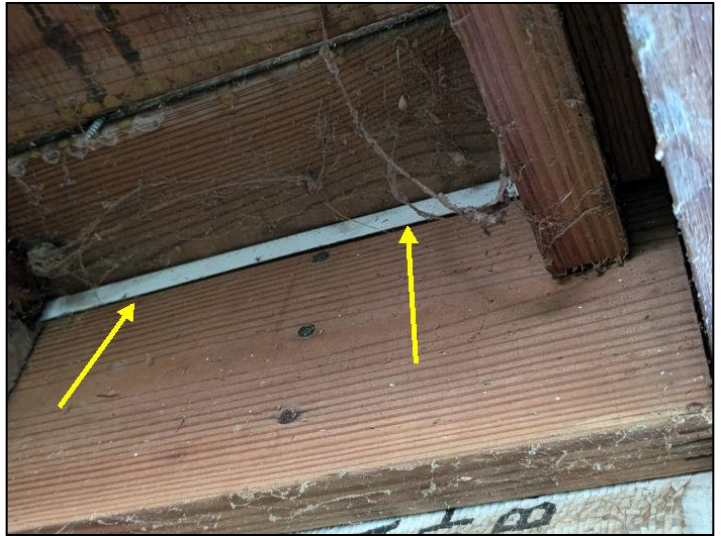
Ledger board flashing was observed on the deck.

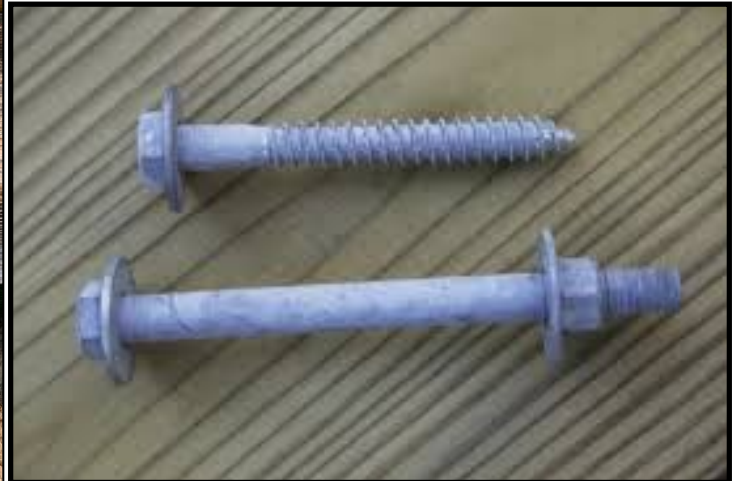
This splice was not on a post. Structural fasteners such as lag bolts/screws were not observed. I recommend installing structural fasteners.

Structural Fasteners: This picture is included for reference. Structural screws are also acceptable.

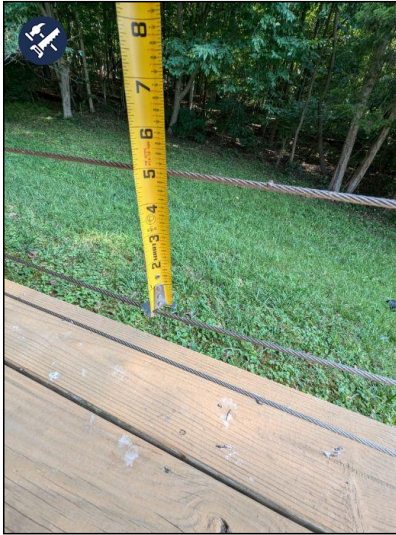
Cable railing is installed, this railing is not considered safe for children because it is climbable and has openings larger than 4 inches. I recommend considering a railing system that is safe for children.

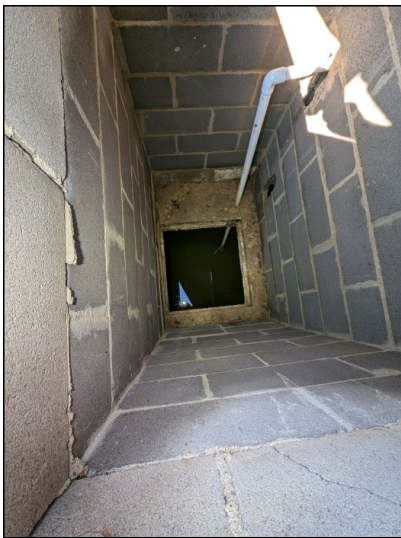
The cistern does not have an approved (child safe) covering installed. This is a potential safety hazard. I recommend repair.

View inside the cistern. Estimated depth to opening is 6 ft. to 7 ft. Depth/size of cistern is unknown.

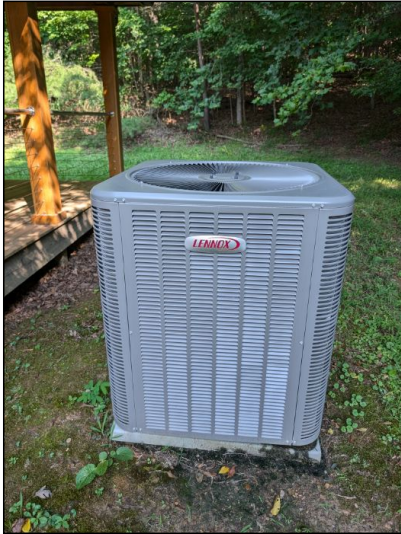
The heat pump unit is a Lennox brand. Age: Nov. 2021 (This unit is approx. 3 years old) The unit operated as intended at the time of the inspection.

This heat pump unit was not level. I recommend leveling the unit.

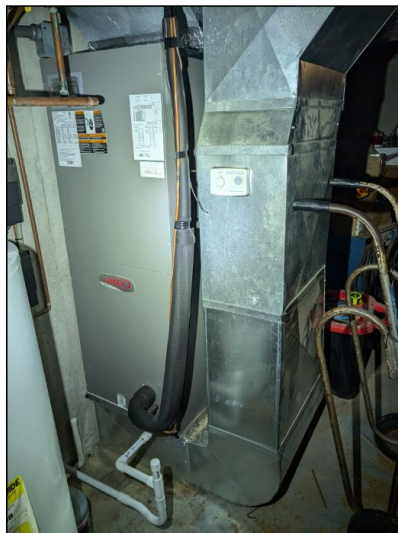
The interior section of the heat pump is electric. Brand: Lennox. Age: May 2021. The unit operated as intended at the time of the inspection.

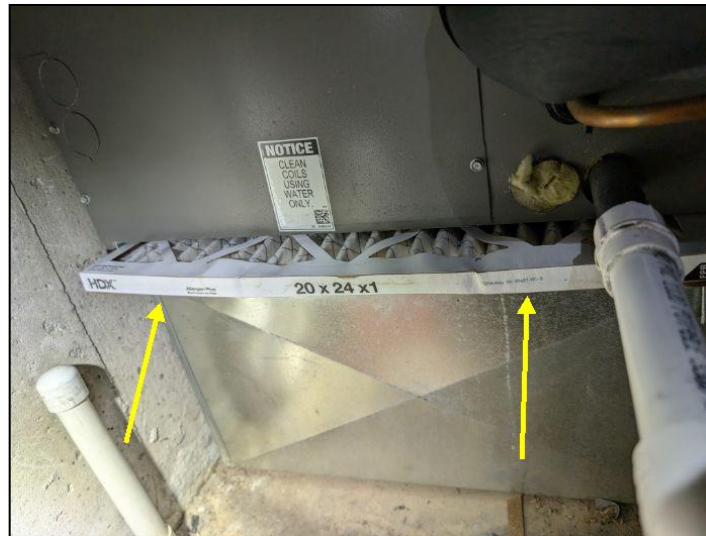
The filter is located here. Size: 20"x24"x1"

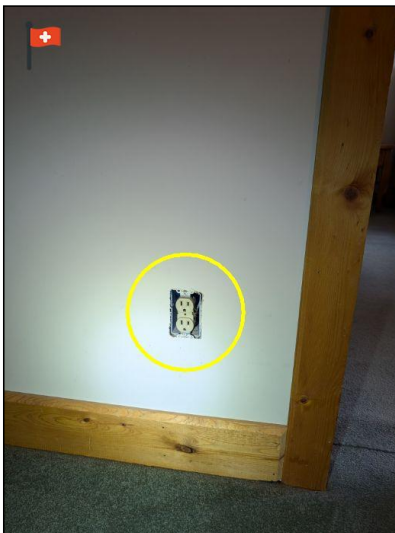
The outlet cover in the upstairs closet is missing. I recommend installing an outlet cover for safety.

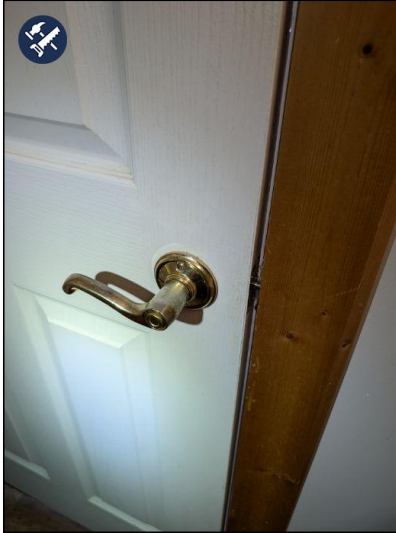
The bathroom door upstairs would not lock. I recommend repair.

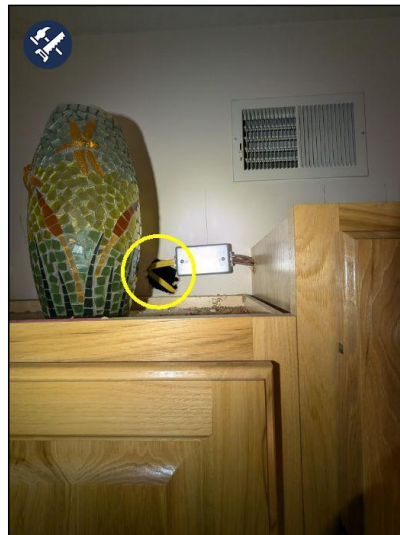
A hole was observed in the kitchen wall. I recommend repair.

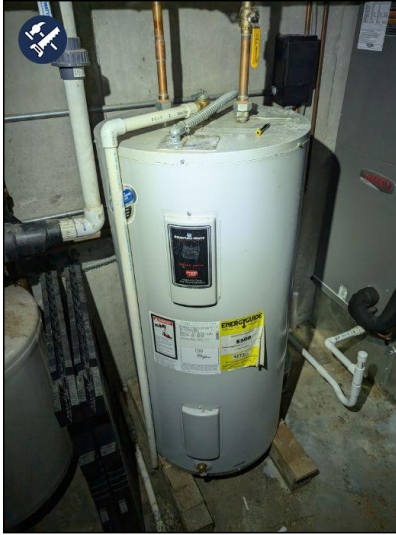
The water heater is electric. Brand: Bradford White. Age: Sept. 2009. (15 years old) The average lifespan of an electric hot water heater is 10 years, I recommend budgeting for a replacement.

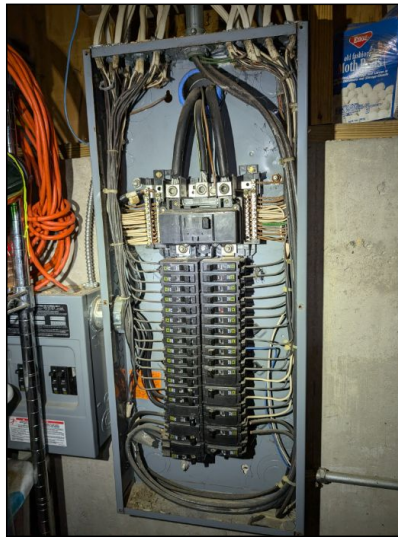
The electrical panel is a 200 amp service, the cover was removed for inspection, no obvious defects were observed.

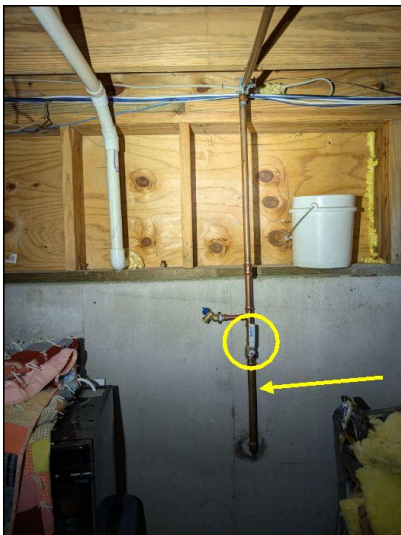
The water supply piping is copper. This is the location of the first water shut off valve as it enters the house.

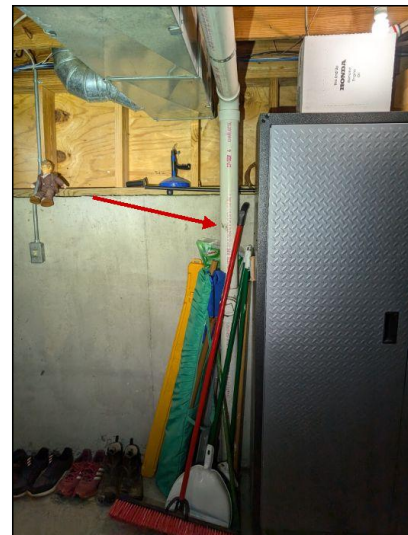
The sewer drain piping seems to exit the front (east) side of the house. This info may help when locating the septic tank.
